ROBINSON DAM

(NDI ID <sup>Nurk</sup> PA-00165  
DER ID <sup>64-136</sup>)

PHASE I INSPECTION REPORT  
NATIONAL DAM INSPECTION PROGRAM

FEB 1981

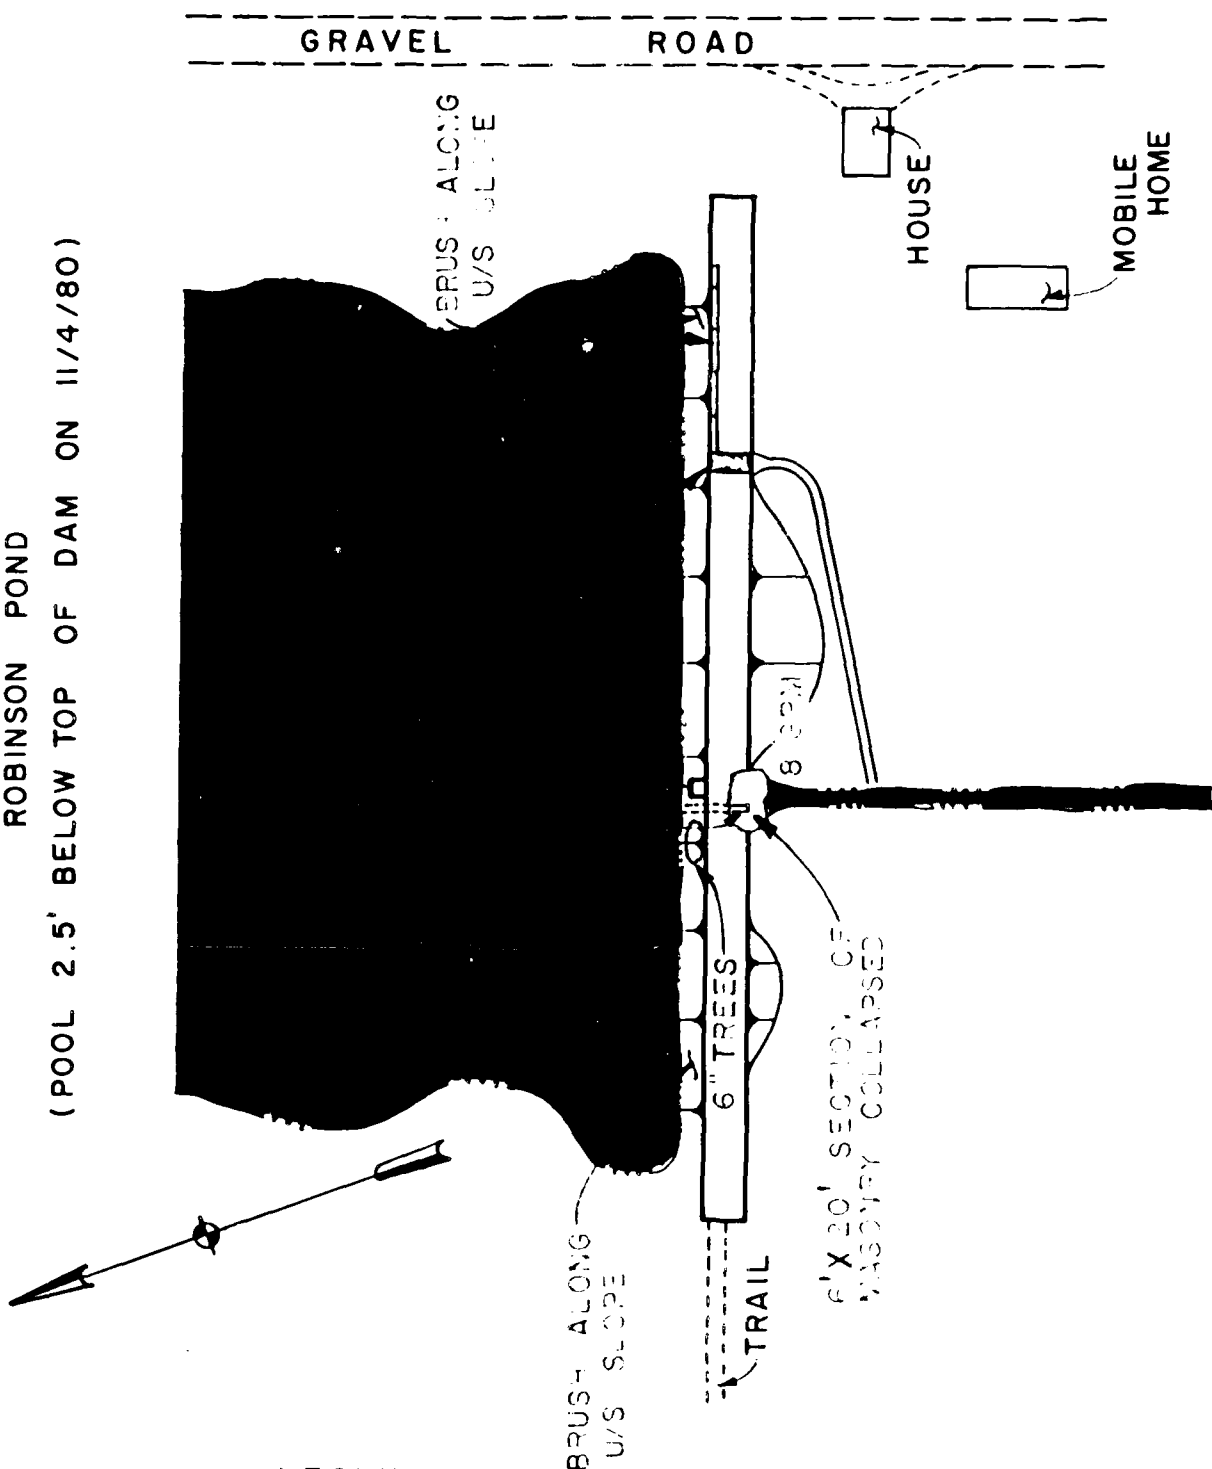
EXHIBIT A-1

(POOL 2.5' BELOW TOP OF DAM ON 11/4/80)

8 GPM INDICATES LOCATION AND QUANTITY OF SEEPAGE

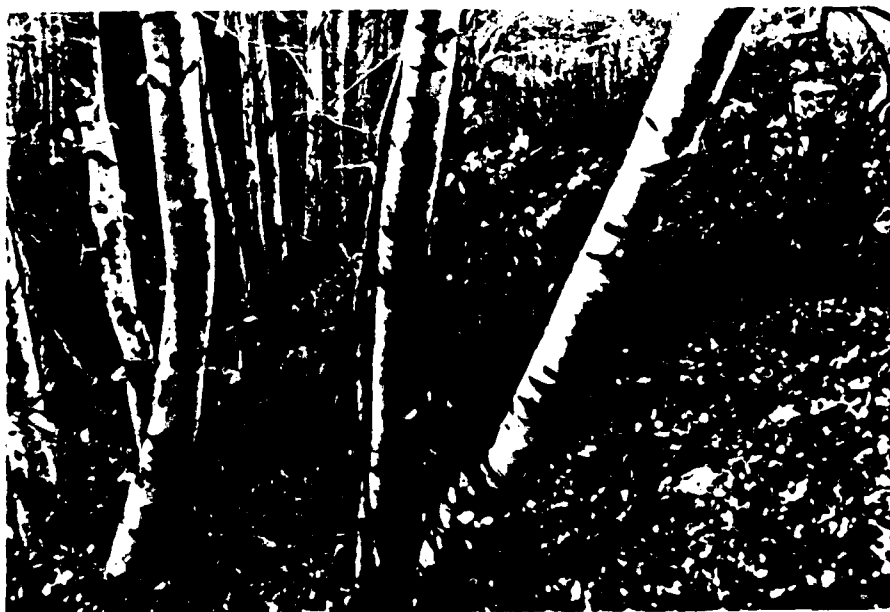
4. Downstream face between spillway and maximum section.
